CASE STUDY

High-speed Hand piece Bur Fracture during mandibular third molar Surgery: A report of two cases with Review of literature

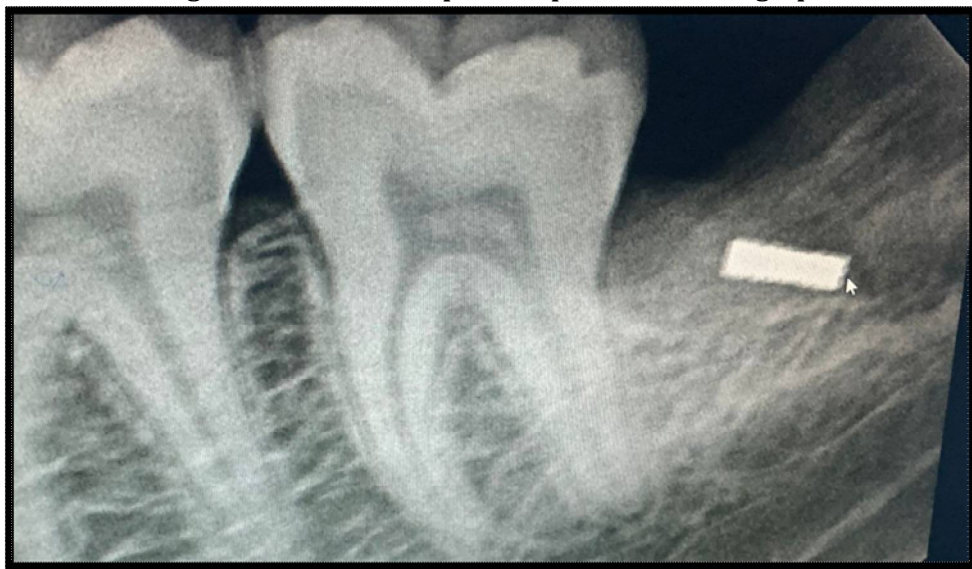
Figure 2: Intra-Oral Periapical view radiograph showing the bur fragment in the socket of the left mandibular third molar.

Irrigation was performed using saline upon completion of the procedure, a shiny object was seen in the socket which was difficult to remove. Upon probing it looked like a broken bur embedded in the bone. This was confirmed upon check the high-speed handpiece with bur, which was broken. An IOPA was performed to reconfirm and locate the exact location of the fractured bur. The fractured bur was removed

by removing part of bone around it. And this was taken up by the section tube. An OPG was performed to confirm and to keep this in record. The socket was closed using 3-000 interrupted suture. Hemostasis was achieved by gauze pressure and patient was dismissed after post-operative instructions were given along with the analgesics brufen 400 mg three times a day for 5 days. The patient was recalled after 1 week for suture removal. There was no post-operative complication after the extraction and after 1 week, healing was noticed after 1 week.

Based on the imaging information, the retrieval technique for a fractured bur should be determined and implemented as soon as the bur fracture and displacement occur. In our cases, the bur was embedded inside the alveolar socket of mandibular third molar, A part of the bone was removed adjacent to the fractured bur for retrieval under local anesthesia as compared to other previous published papers, Le K [16] retrieval was done by using twizzer and hemostat under local anesthesia. Whereas a case published by Mastuda [15] reflected the mucoperiosteal flap and removed the alveolar crest bone of the right mandibular third molar region. Then, the foreign body was removed under General Anesthesia as the bur was displaced in the deeper tissues. In both of our cases (Fig. 2, 6) fractured bur was sucked up through the suction tube.

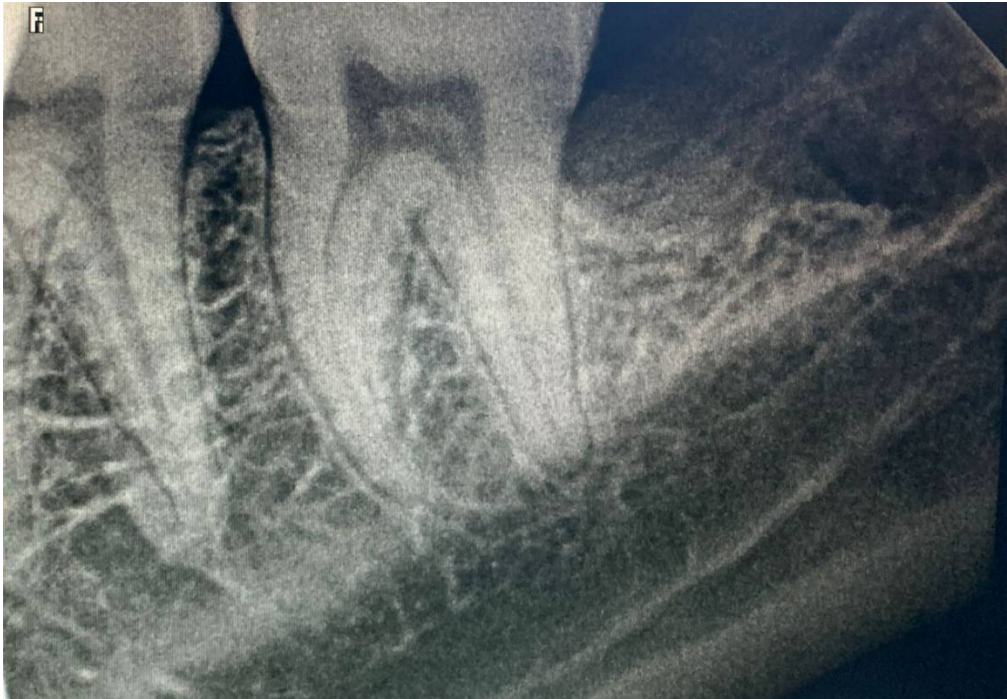
Figure 3: Post operative Intra-Oral Periapical view radiograph showing complete removal of the bur segment.

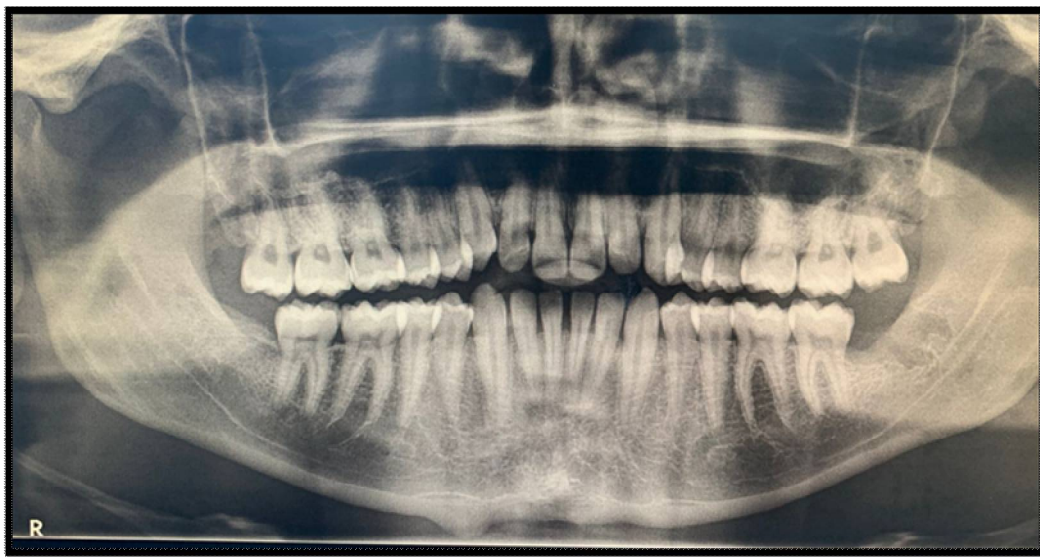
Figure 4: Postoperative panoramic view showing complete removal of the bur segment.

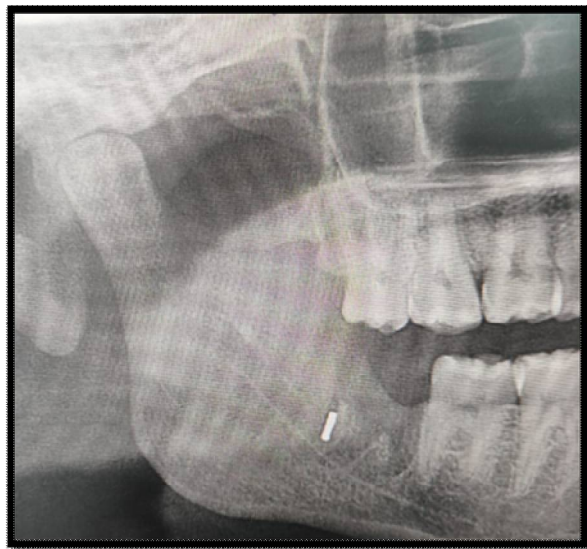
Figure 6: Intra-Oral Periapical view radiograph showing the bur fragment in the socket of the right mandibular third molar.

A 27 years old patient was referred to the Oral Surgery clinics for surgical extraction of mandibular right molar (#48). On clinical and radiographic examination revealed a distomolar impacted teeth. Written informed consent was taken from the patient before proceeding for the surgical extraction. The impacted teeth were removed under local anesthesia with 1: 100,000 epinephrine using 2% Lidocaine with 1:100,000 epinephrine with inferior alveolar, lingual, long buccal nerve blocks. Incision was given and buccal guttering was performed and distobuccal bone was removed. During bone removal, an accidental breakage of the bur had taken place, impacted tooth was removed and IOPA was performed to locate the fractured bur. The fractured bur was removed by removing a part of the bone around the bur. This fractured bur was taken up by the suction. To confirm, an IOPA was again taken. The socket was closed by 3-000 black silk. The patient was recalled after 1 week along with the analgesics brufen 400 mg three times a day for 5 days and patient reported no post-operative complication and socket was healing uneventfully.

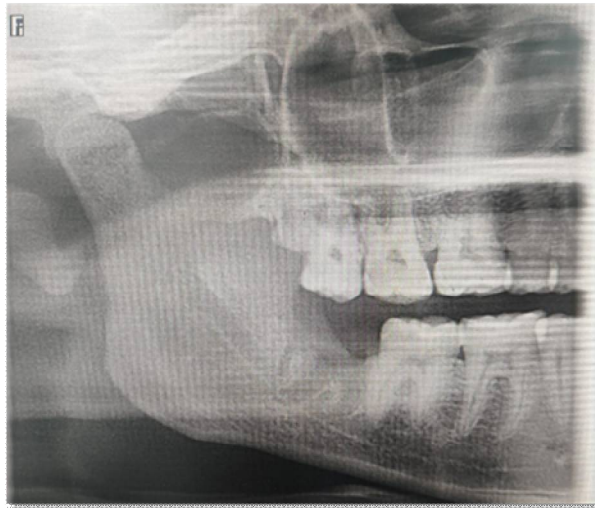
Figure 7: Post operative Intra-Oral Periapical view radiograph showing complete removal of the bur segment.
